## CAMINO DE LA PLACITA

The southern end of Camino de la Placita, from the intersection at Paseo del Pueblo north to Don Fernando Rd., is a corridor rich in history and ripe with opportunity. It is the historic site of Our Lady of Guadalupe Church, as well as the link between the Plaza and the gallery district along Ledoux Rd., one of the oldest streets in the town. It is also an important point of entry for tourists to the Plaza.

During the YourTown design charrette, residents expressed the desire to implement a number of solutions, on a variety of scales, addressing the connectivity issues in Taos' arts and cultural district. These include: increased walkability, legibility, and amenity. All improvements are intended to enhance the overall pedestrian and vehicular experience.

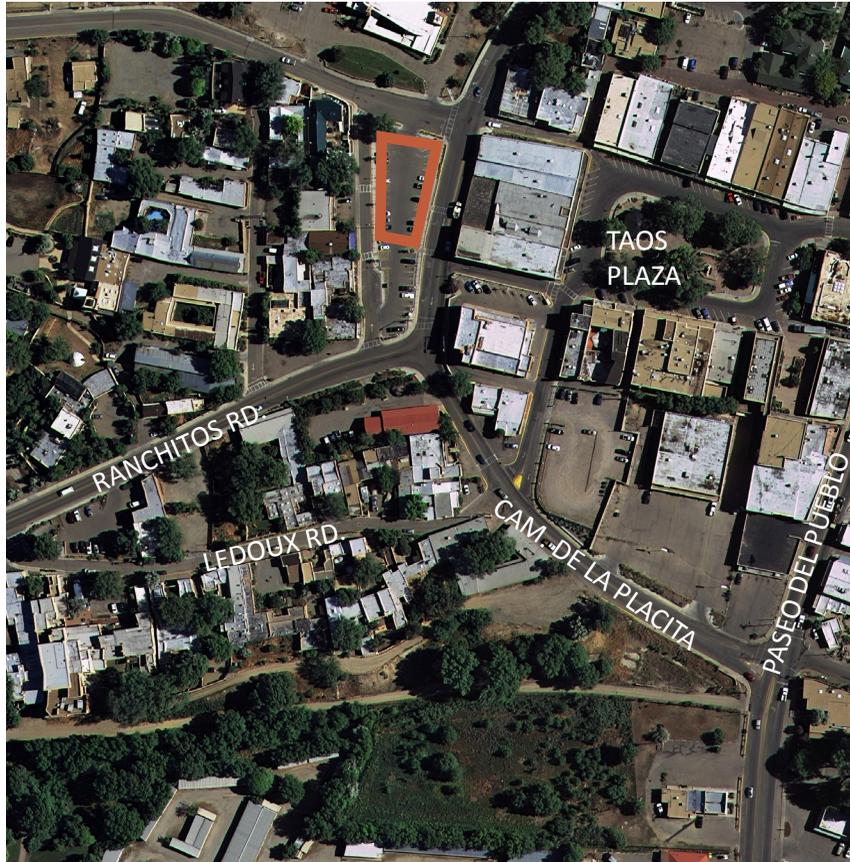
Existing condition; historic site of OLOG church is outlined in orange

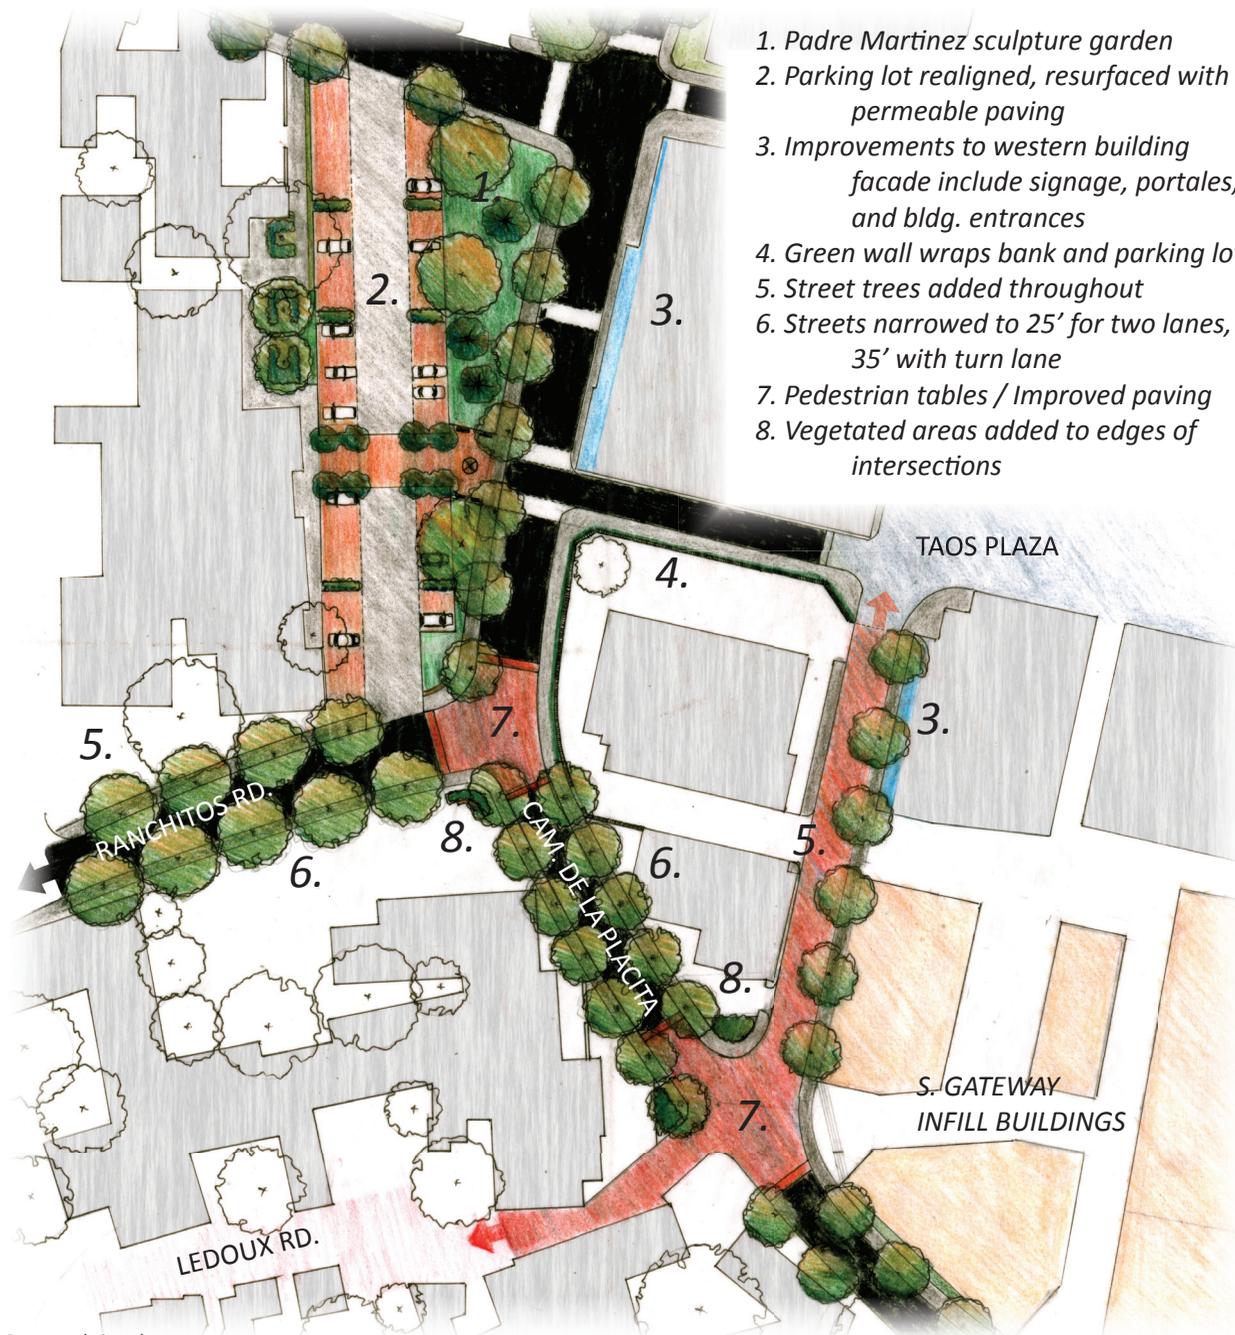
Proposed site plan

1. Padre Martinez sculpture garden
2. Parking lot realigned, resurfaced with permeable paving
3. Improvements to western building facade include signage, portales, and bldg. entrances
4. Green wall wraps bank and parking lot
5. Street trees added throughout
6. Streets narrowed to 25' for two lanes, 35' with turn lane
7. Pedestrian tables / Improved paving
8. Vegetated areas added to edges of intersections

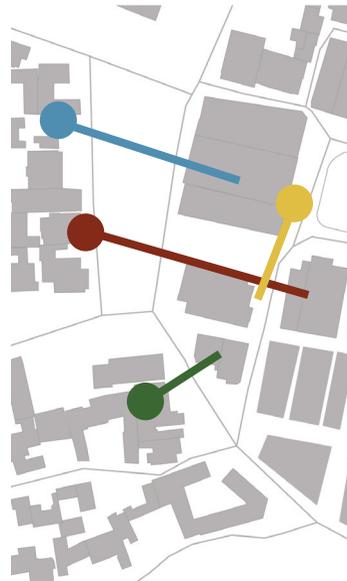
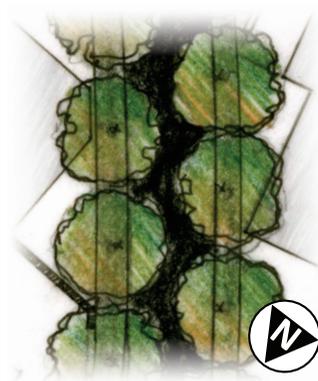
Section to NW through Placitas

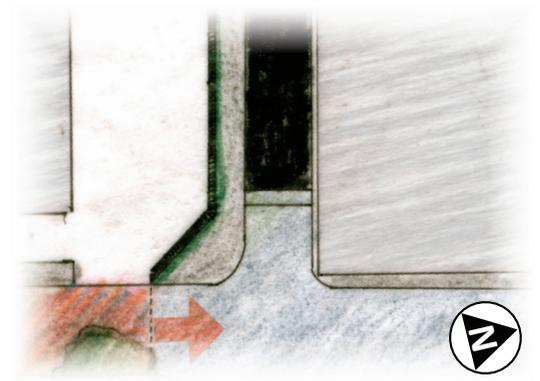
Section to West through green wall

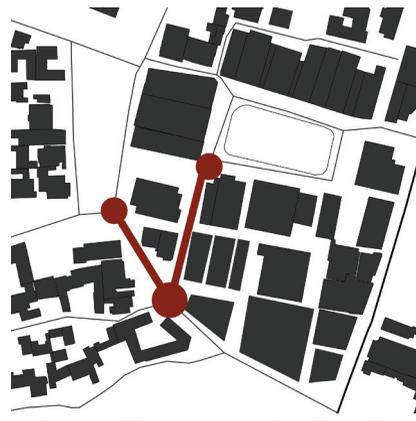
Pedestrian tables: Paving at sidewalk Level

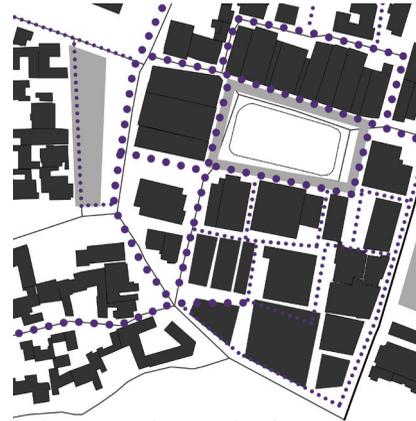
Pedestrian circulation and parking

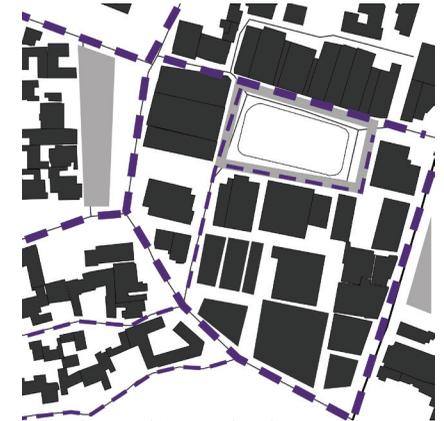
Vehicular circulation and parking

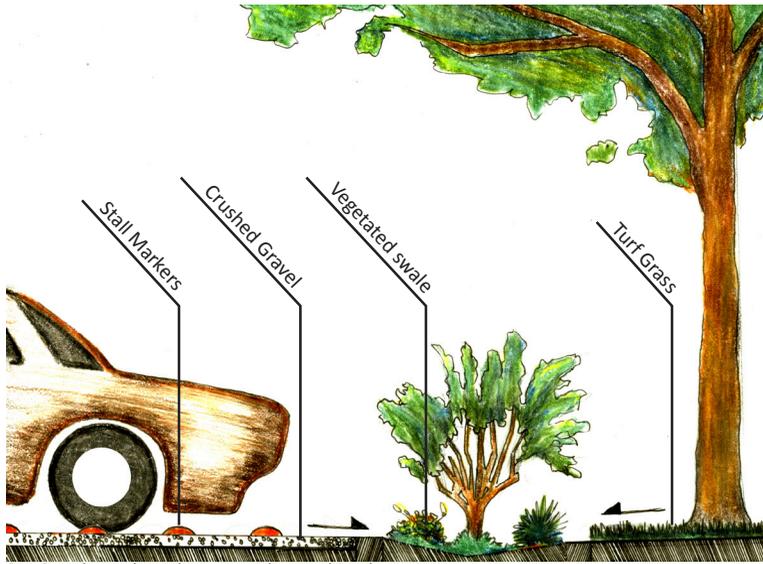
Section through sculpture garden parking lot

Dona Luz Rd. has been eliminated and the parking lot re-configured, using a permeable surface treatment, both to make room for the garden, and to provide an enhanced parking experience, without having to lose a single parking space.

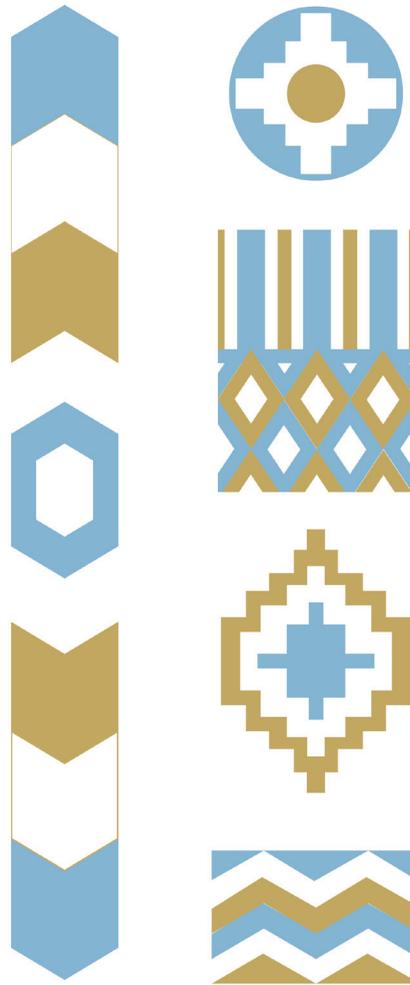
Potential paving patterns

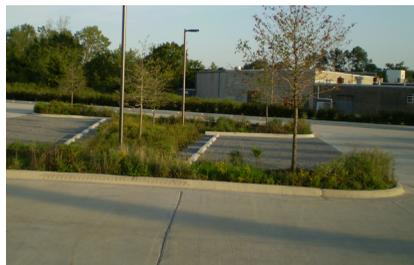
Pervious parking w/ paved circulation

*Permeable lots with drainage into bio-swales for a more integrated and aesthetic parking solution.*

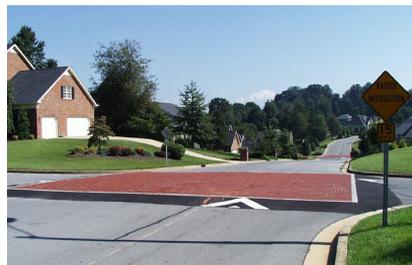
Pedestrian table

*Pedestrian tables and paving changes @ intersections slow traffic and allow for a shared pedestrian / vehicular experience.*

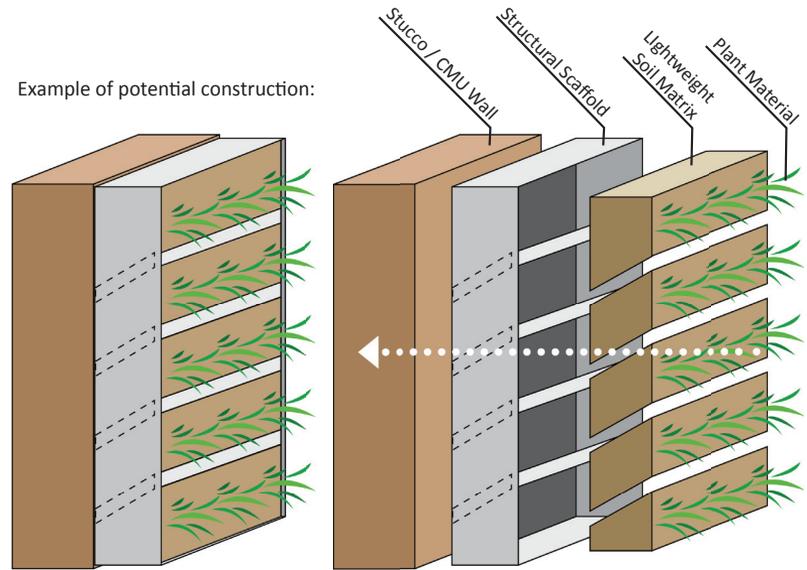
Plant Origin	Suggested Species	Design Concept
Native	<ul style="list-style-type: none"> <li>verbena</li> <li>horsemint</li> <li>wild onion</li> <li>yerba mansa</li> </ul>	
European	<ul style="list-style-type: none"> <li>thyme</li> <li>fennel</li> <li>cilantro</li> <li>garlic</li> </ul>	
C. American	<ul style="list-style-type: none"> <li>paprika</li> <li>m. tarragon</li> <li>cayenne</li> <li>hierba santa</li> </ul>

Diagram of concept for green wall: the 3 intertwined cultures of Taos

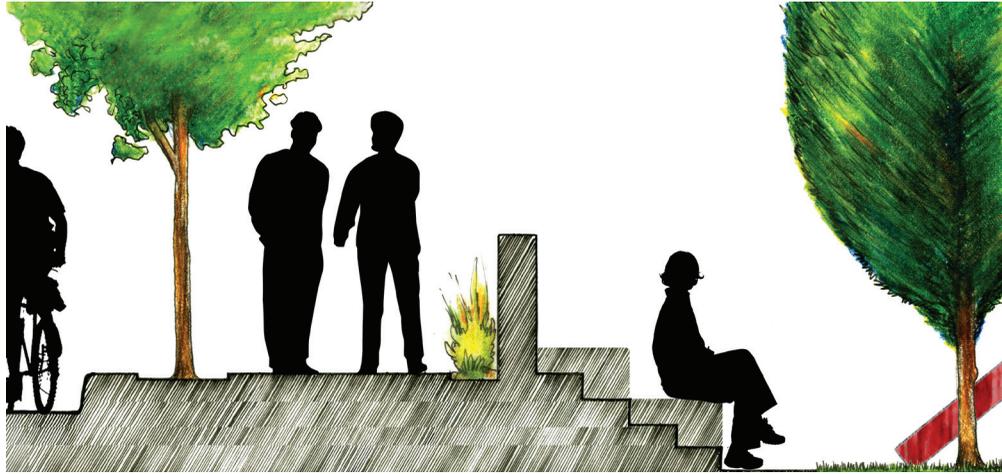
Enlarged Street Section through Sculpture Garden Steps

...grade change will allow the garden to be sunken from the sidewalk level, offering the chance to step down into a place of quiet respite shielded from the noise and bustle of the road.
